Re: San Jacinto River Waste Pits Superfund Site Time Critical Removal Action  
TCRA Cap Repair Plan  
CERCLA Docket No. 06-12-10  
Project Number: 090557-01

ATTACHMENT A  
TCRA QUARTERLY MONITORING  
MAINTENANCE REPORT

**Re:** Time Critical Removal Action (TCRA), Quarterly Monitoring Maintenance  
Requirements Report

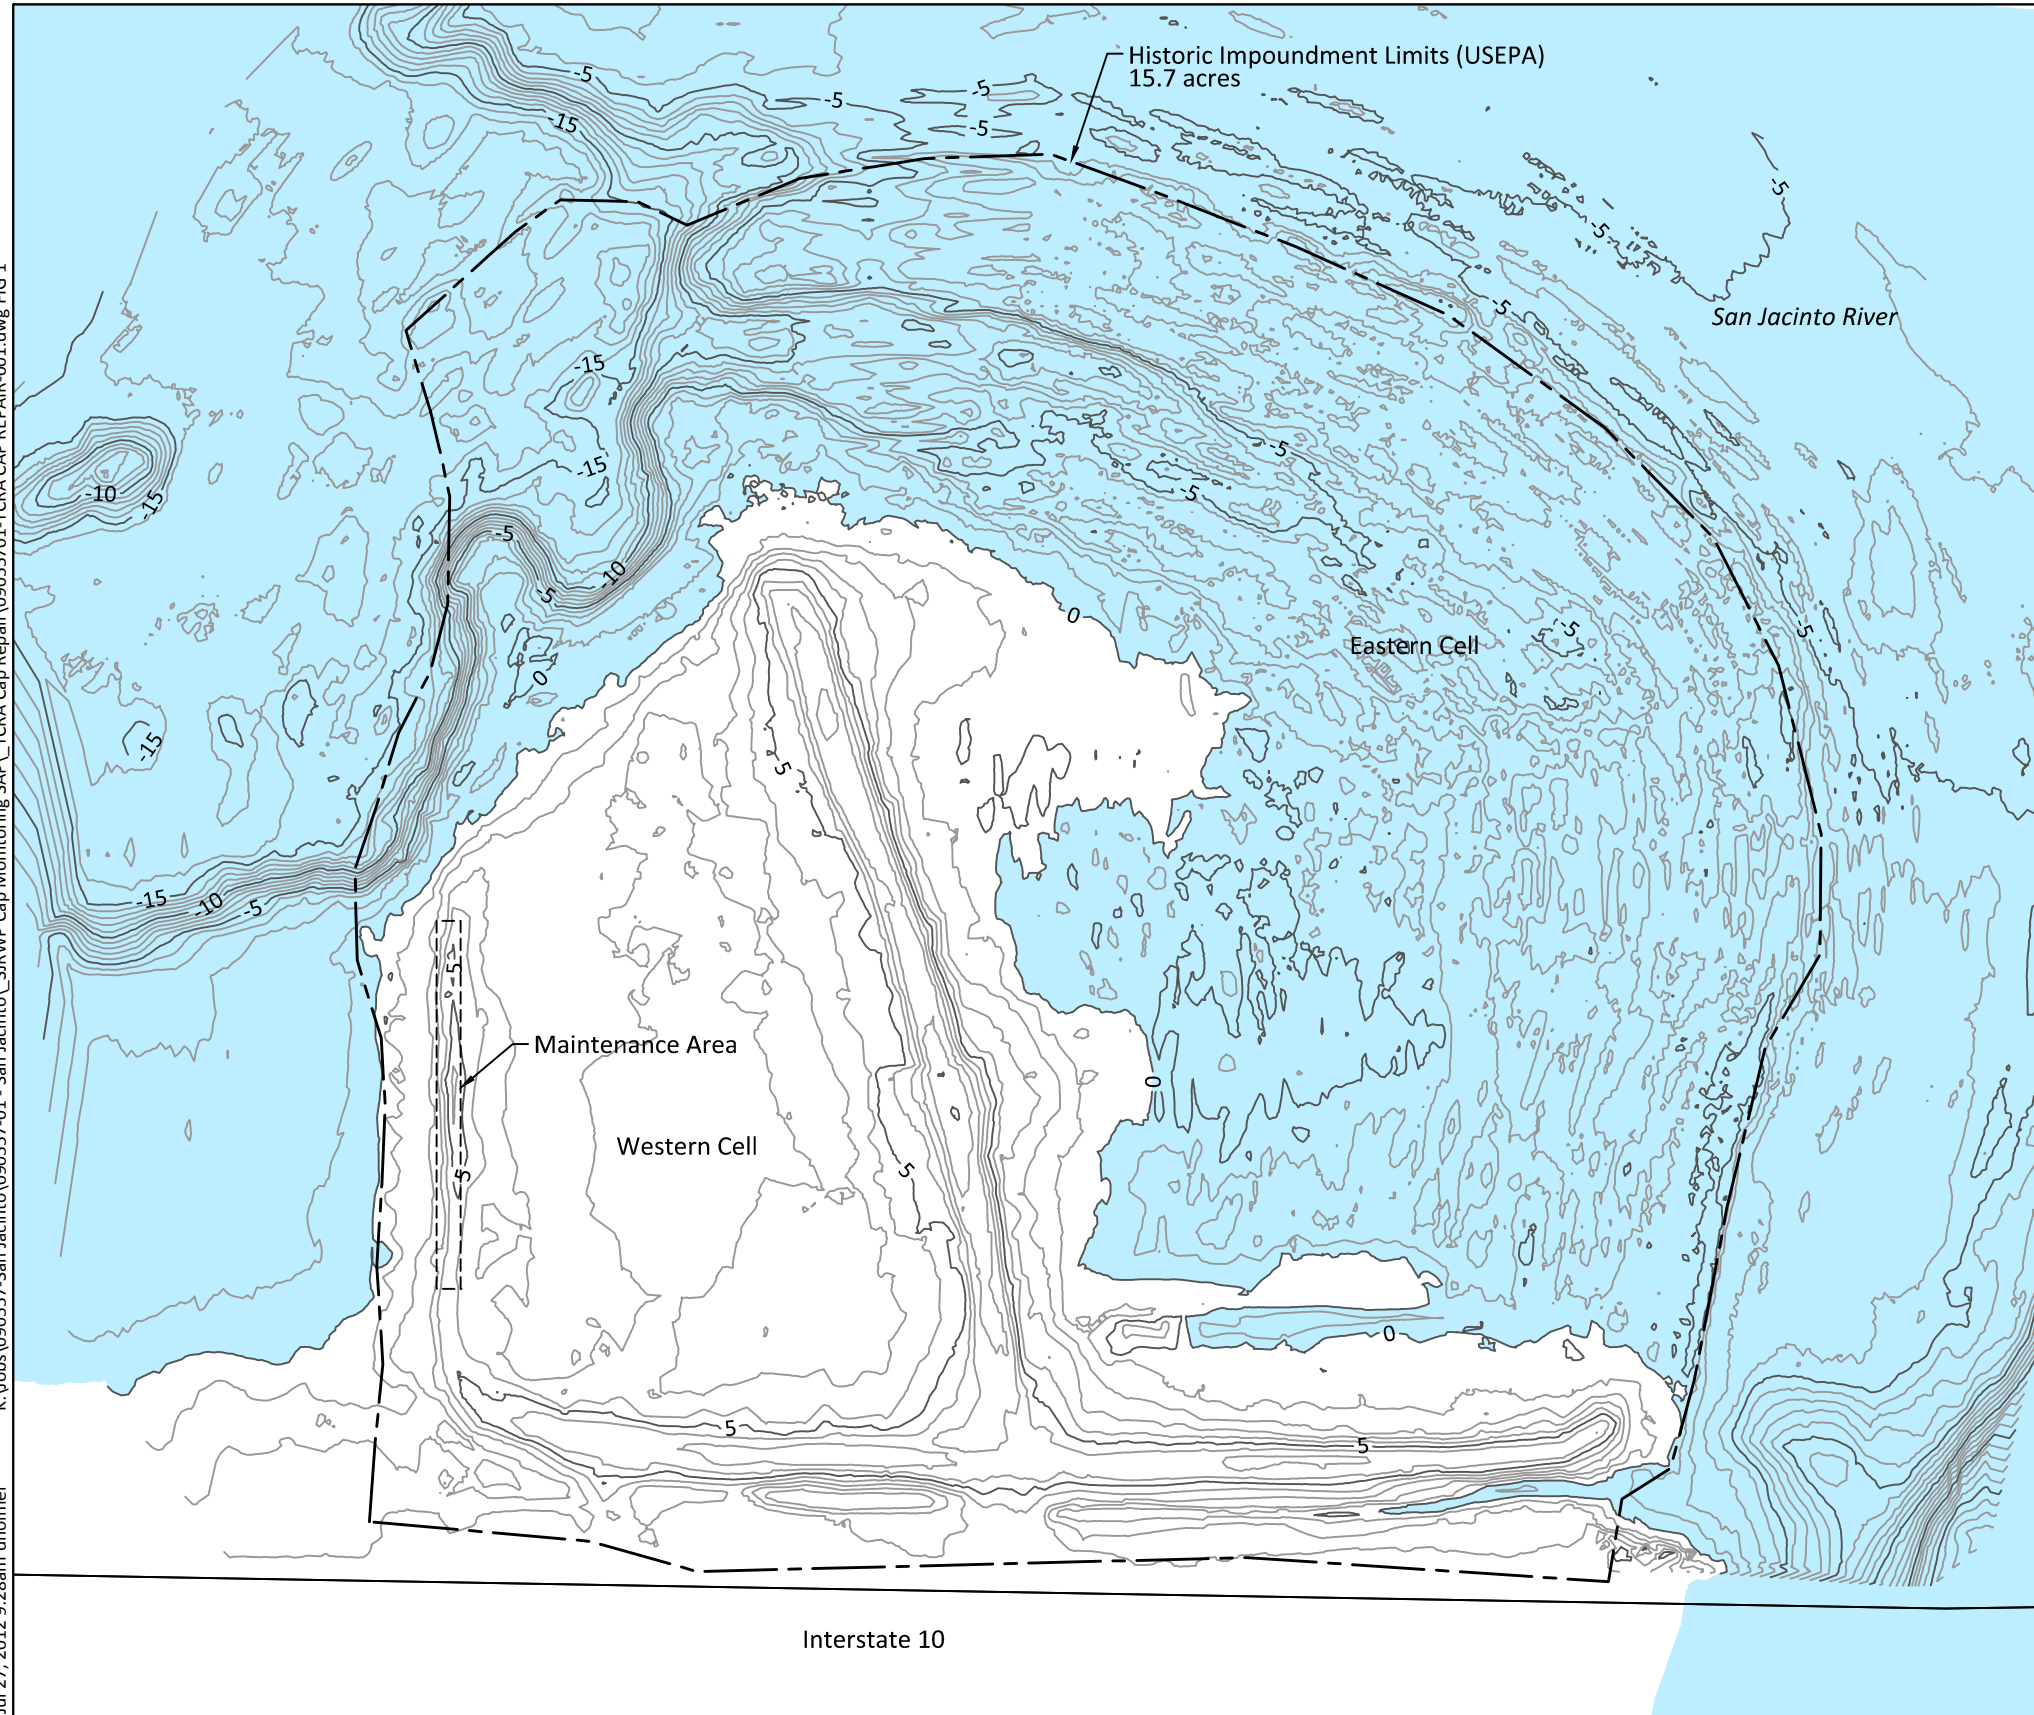
Figure 1 – TCRA Site Map

TCRA Site and shows where maintenance was noted to be necessary. Observations indicated that within the “Maintenance Area” shown on Figure 1 (hereinafter referred to as “Maintenance Area”) there are localized areas of the western berm face subgrade beneath the geotextile where the slope is steeper than in other areas of the berm face.

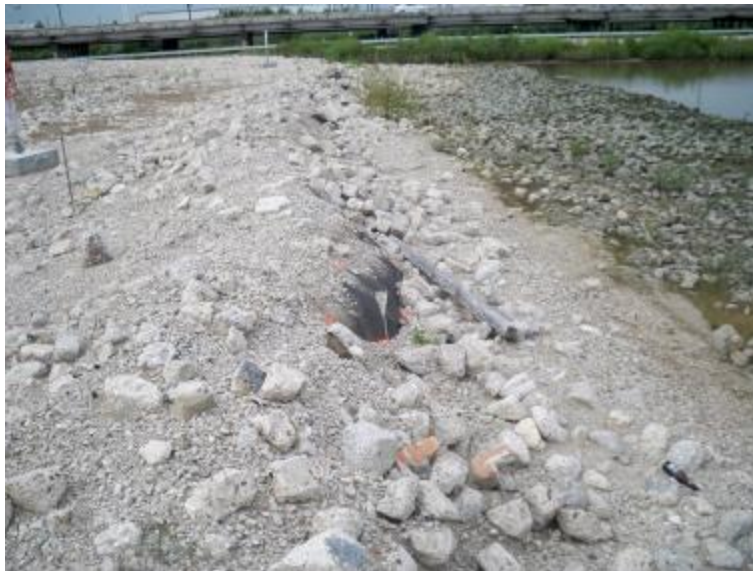
The visual inspection indicated intermittent and discrete areas along the western berm where the cap armor was thin and exposed geotextile was observed. The geotextile layer was clean, undamaged, and there is no evidence that the underlying materials were exposed. Photographs taken during the inspections that document these observations are attached (Figures A-1 and A-2). There was no damage observed to on-Site signage or the perimeter fencing. All other portions of the armored cap that were visible during the inspection were observed to be intact, with no breaches or other damage.

Photo 1: Walking south atop western berm. Note bulge in geotextile covered slope.

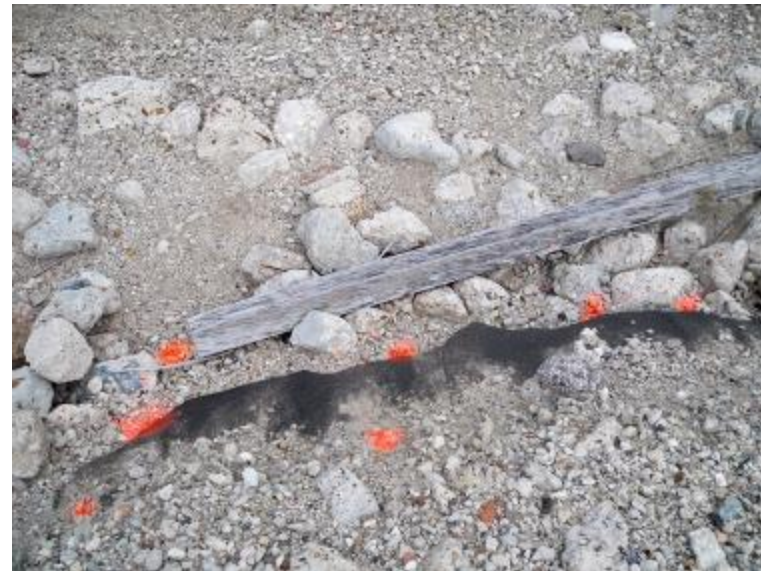
Photo 2: Looking down on exposed fabric shown in Photo 1.

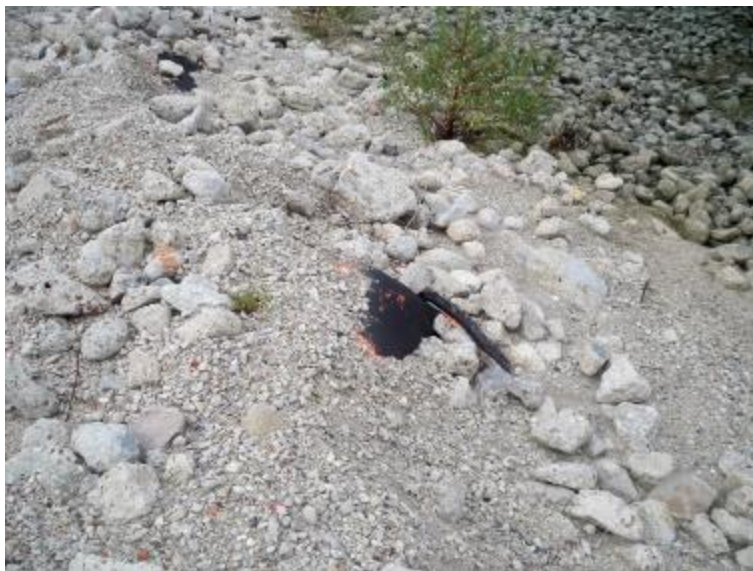
Photo 3: Walking atop western berm. Note bulge and slope of geotextile covered slope seen in background of Photo 1.

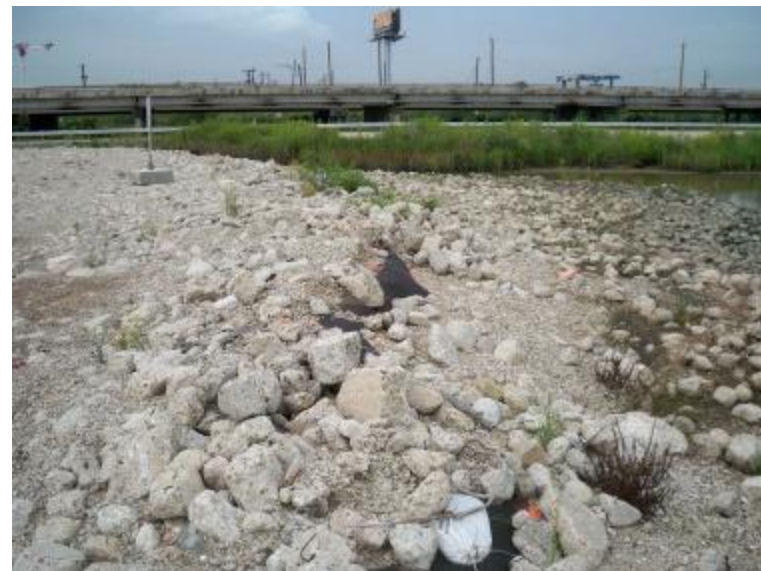
Photo 4: Walking atop western berm near southwest corner. Note slope/bulge of geotextile covered slope.

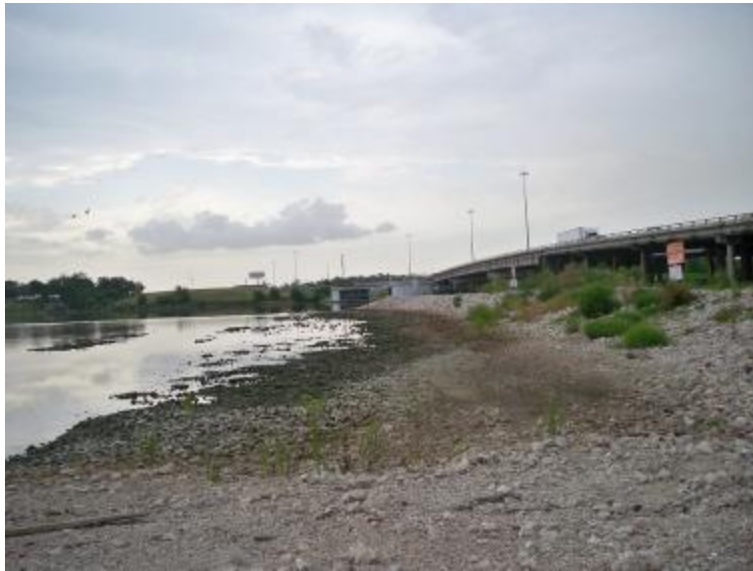
Photo 5: Southwest corner of eastern cell, looking east along the north face of the south berm.

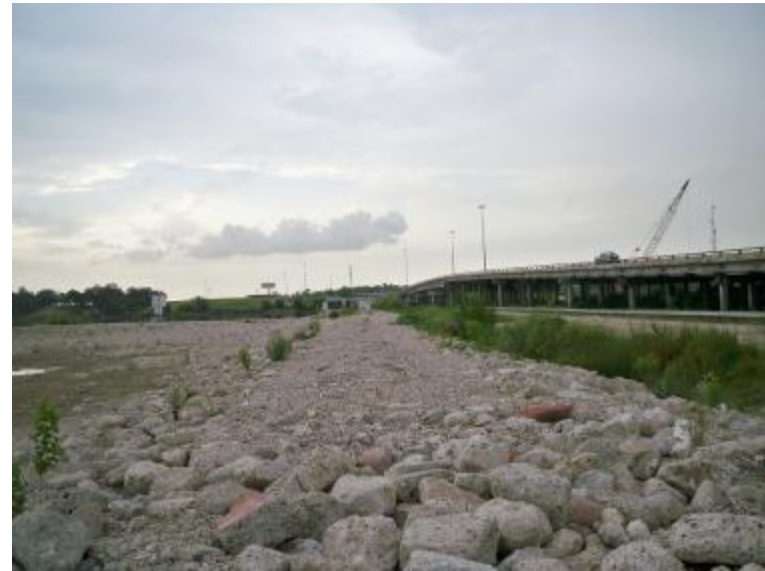
Photo 6: Southwest corner of western cell, looking east atop the south berm.

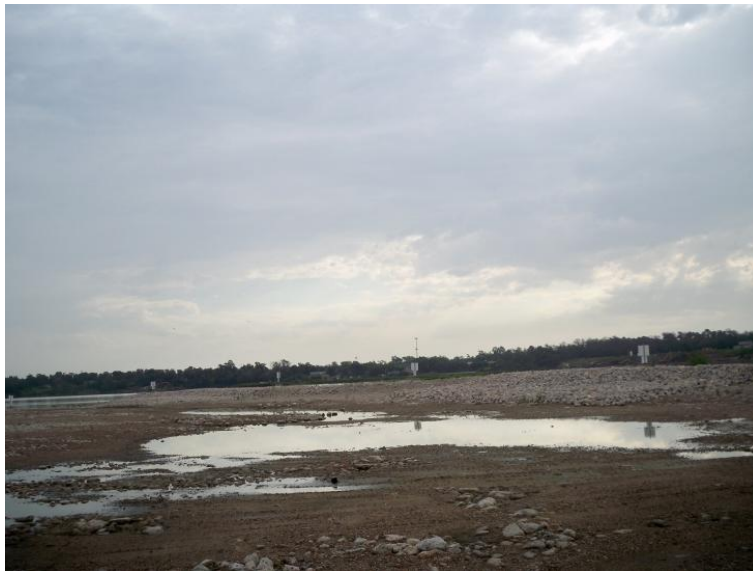
Photo 7: Looking across the western cell from southwest to north-east. Note warning signs atop the central berm.

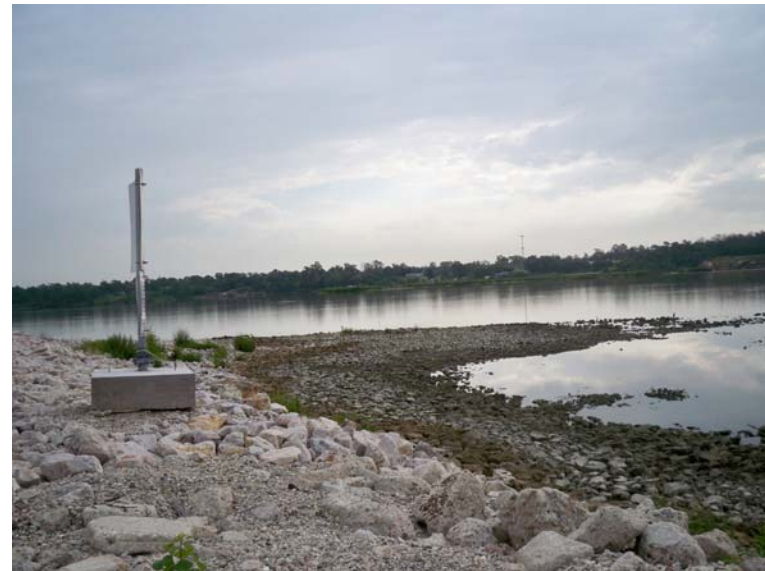
Photo 8: North half of central berm looking down slope and to the northeast.
